Port of Dampier – Risk of Jellyfish

Number: D18/2025

Date: 25/08/2025

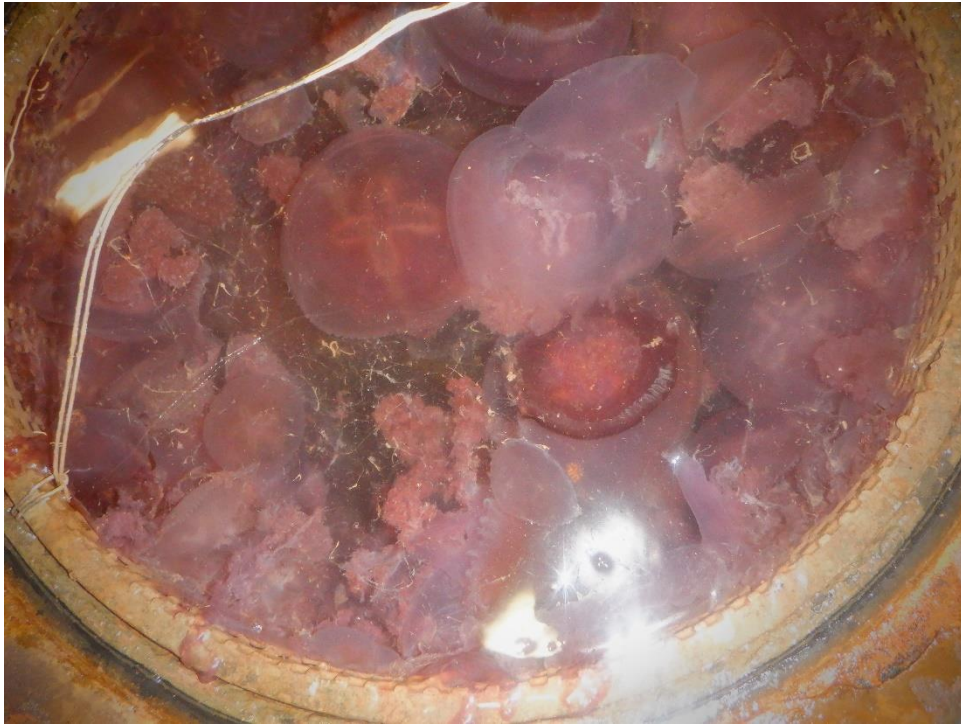
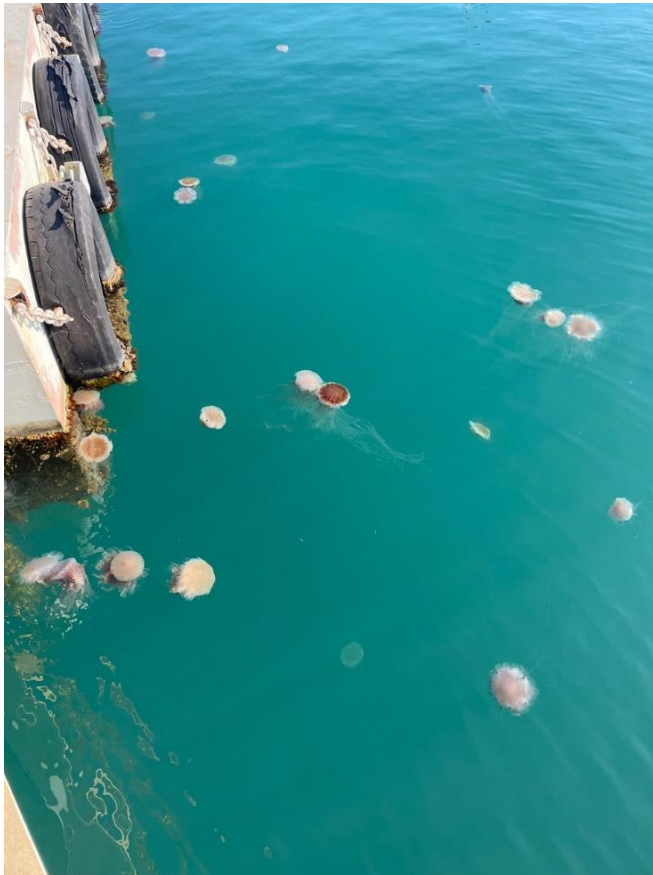
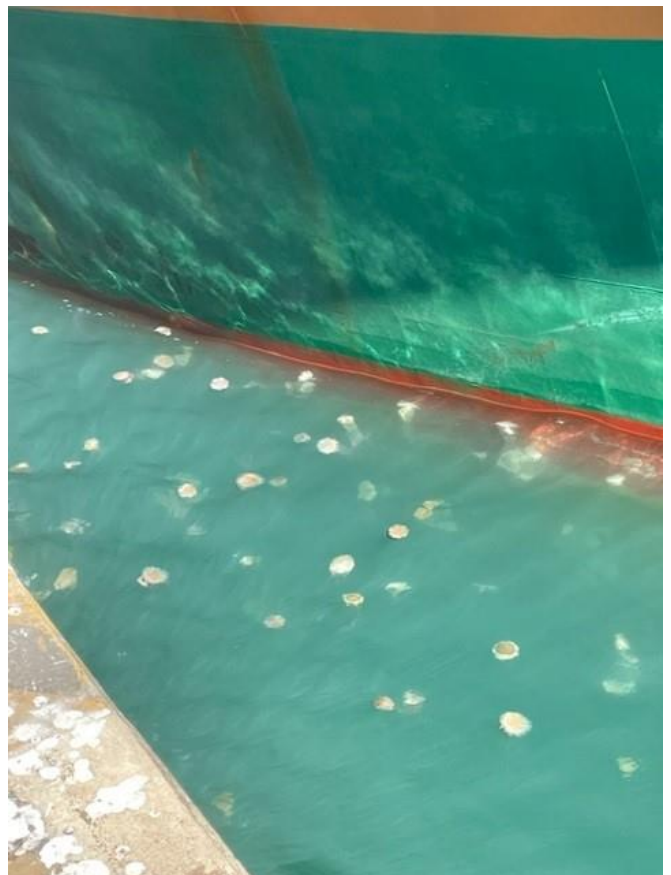
Mariners are advised that an increased number of jellyfish has been observed waters in and around the Port of Dampier. Two potential risks from the presence of jellyfish have been reported:

- 1) Seawater strainer blockage causing issues related to cooling, resulting in engine slow down and shutdowns
- 2) Hazards of the jellyfish stingers coming in contact with the exposed skin of the crew. This hazard has been reported in two instances:
 - a) Crew cleaning seawater strainers to remove the jellyfish
 - b) Crew handling mooring rope after the rope has been in the water

Vessels are advised to carry out a risk assessment and include below risk mitigation:

- 1) Inspect and clear their seawater strainers before commencing inbound and outbound passage.
- 2) Monitor cooling temperature and pressure whilst transiting in port waters and have engine crew on standby to respond without delay.
- 3) Appropriate PPE to be worn by crew clearing the filters and any deck crew handling the mooring ropes to prevent any contact with the jellyfish
