MANGROVE REHABILITATION GUIDELINES

A242767

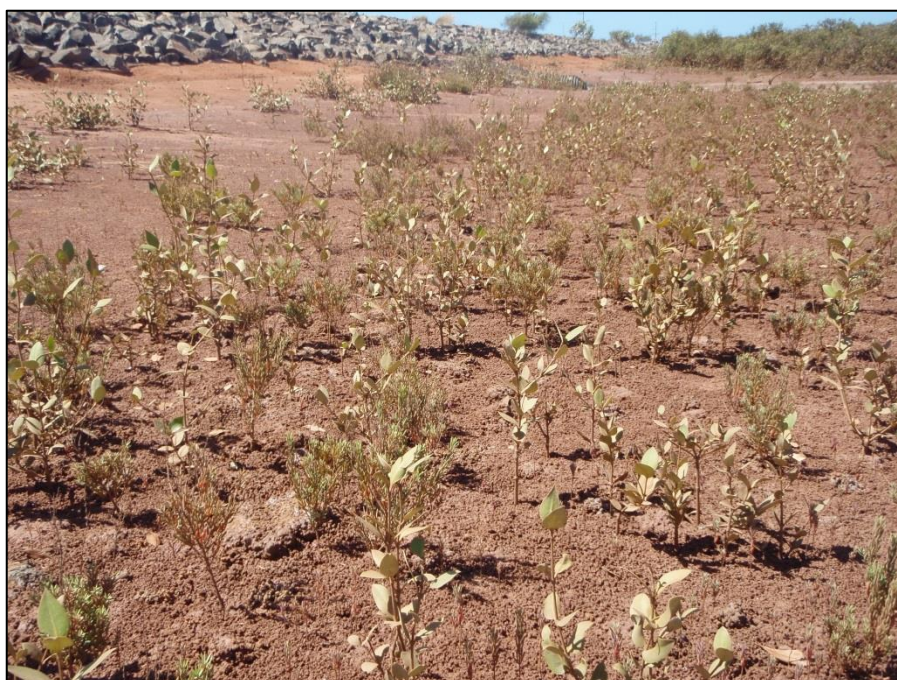
Plate 1 : Mangrove seedling recruitment on high tidal mud flats next to the Utah Point Road.

It should be noted that there are several areas in Port Hedland where infrastructure such as roads and levees constructed within mangrove and tidal flat areas have provided a propagule deposition area and, in combination with providing lower salinity conditions, they are areas where mangrove seedling recruitment commonly occurs. In some cases, this may be in areas where mangrove previously did not occur. For example, a substantial amount of seedling recruitment has occurred on high tidal flats adjacent to the base of Utah Point Road, Port Hedland in an area that was previously devoid of mangroves (see Plate 1). If such a scenario has developed within an area requiring rehabilitation, then where practicable, care should be taken during rehabilitation works not to damage these mangrove seedlings or existing coppiced mangroves, as it is anticipated that this vegetation will be beneficial in providing more stability for additional rehabilitation via recruitment of seedlings.

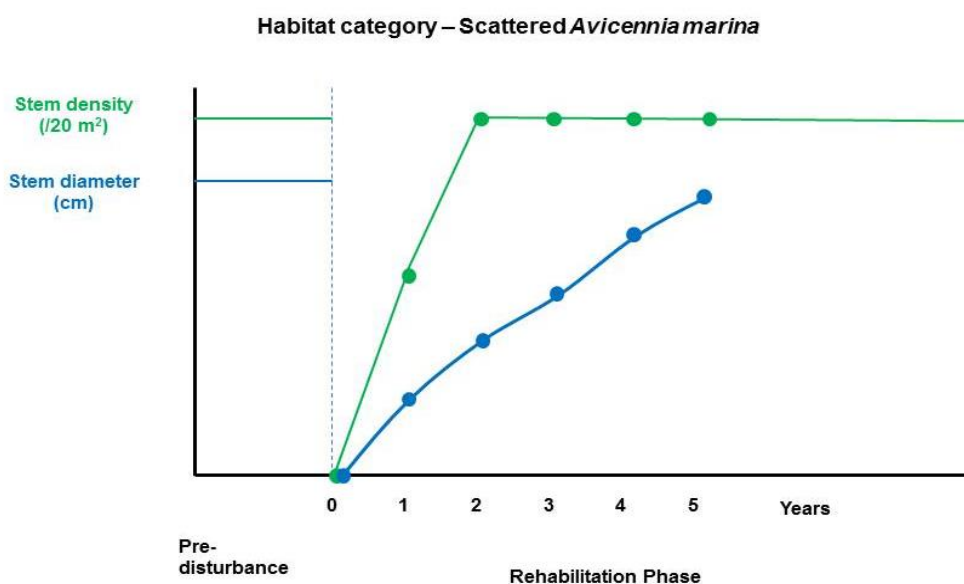
Figure 1: Theoretical rehabilitation trajectory for a disturbed mangrove habitat category in the Pilbara. The metrics suggested have illustrative units. For example, stem density might be in any convenient and measurable area. It would be envisaged that a mean and standard error would be quoted.

It should be noted that due to the current lack of documented mangrove rehabilitation projects from the Pilbara coast, the rehabilitation trajectory shown in Figure 1 is theoretical at this stage and would need to be reviewed in the future as further information becomes available.
