Dampier Cargo Wharf Extension and Landside Redevelopment Project

Benthic Communities and Habitat Cumulative Loss Assessment

REPORT NUMBER: 21WAU-0068 / R210276

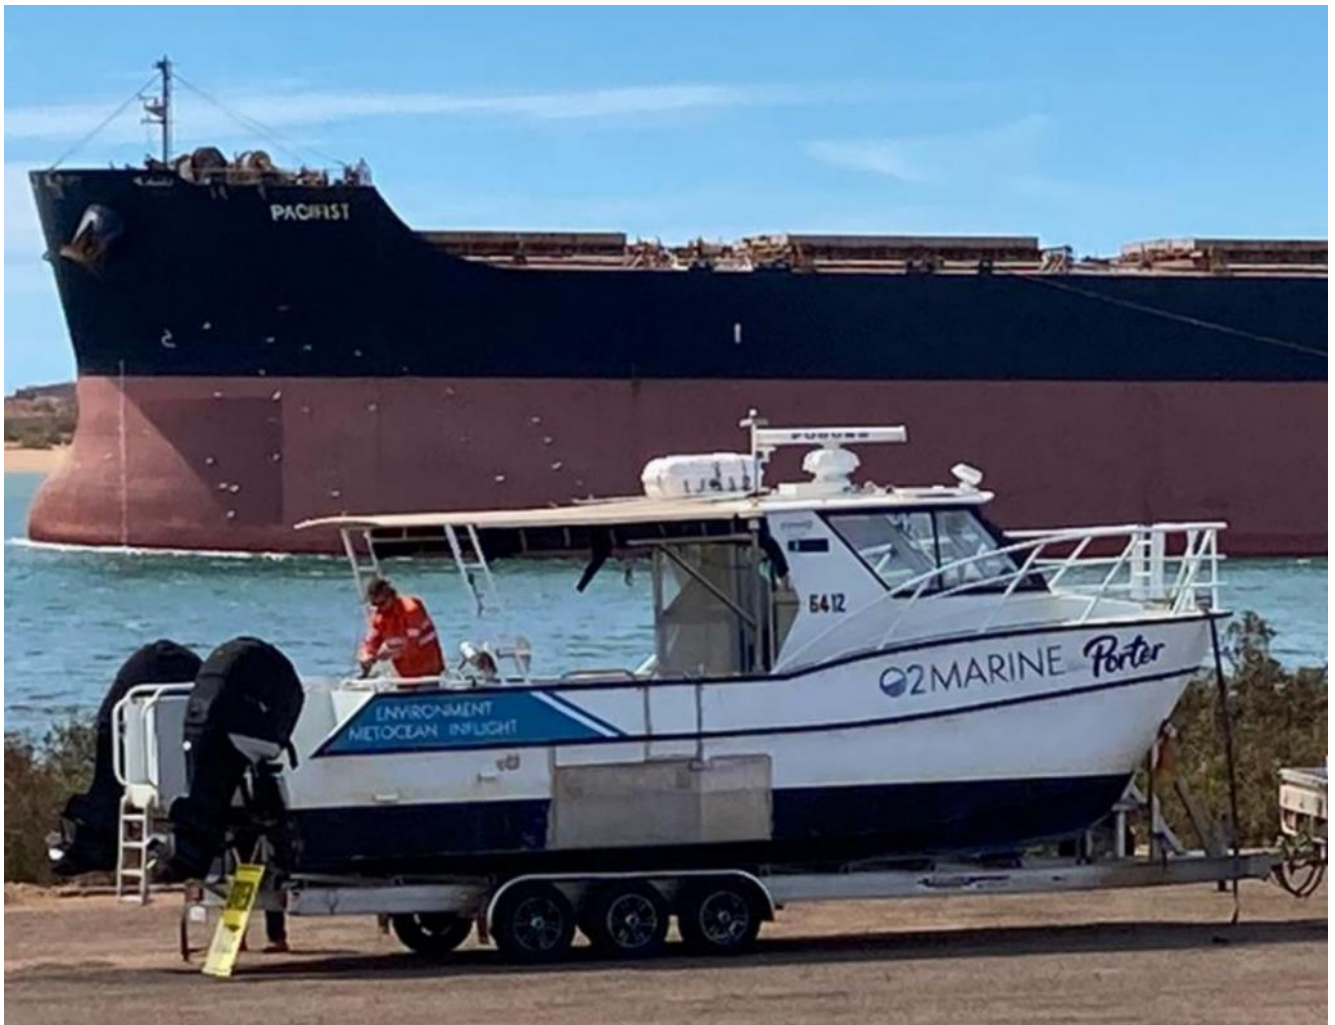
Figure 5 O2 Marine's survey vessel 'Porter'.

O2 Marine undertook the survey on its 8.5m survey vessel 'Porter' to undertake the scope of works (Figure 5). The proposed O2 Marine vessel is currently in survey, meeting all Australian Maritime Safety Authority and Department of Transport requirements. Porter is also fitted with AIS in accordance with PPA standards. Vessel registration and specifications can be found in the survey HSE plan.
