## Port of Dampier – Vessel Safe Access Accommodation Ladders

Number: D19-2026

| <b>Details:</b> | Safety advice for suspended accommodation ladders and ship-to-shore access arrangements |

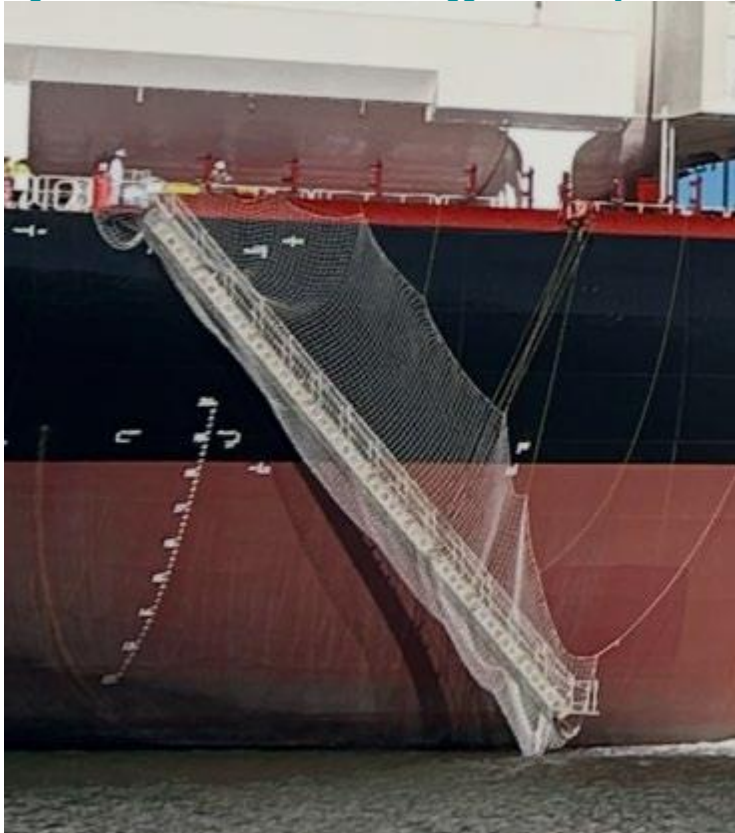
Figure 1: Accommodation ladder rigged correctly

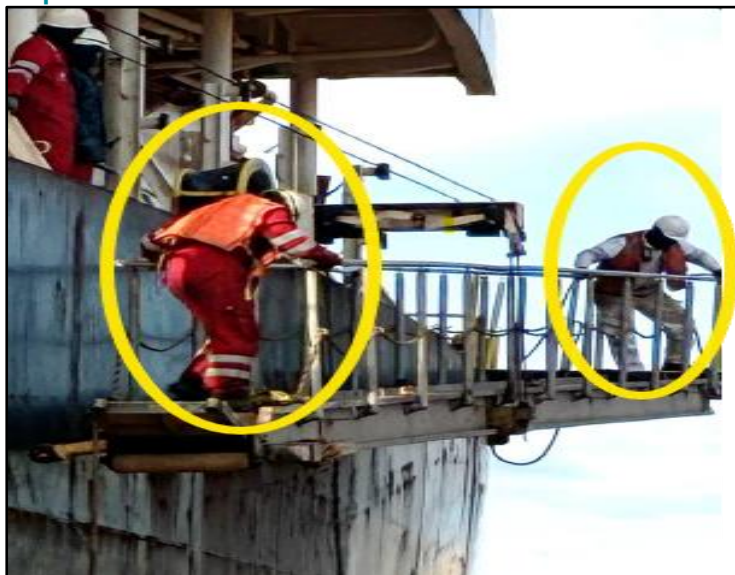
Figure 2: Unsafe accommodation ladder rigging, showing crew working without fall-protection equipment, incorrectly worn PFDs, and support personnel positioned outside ship rails near the ship's side without PFDs
